Thermographic Inspection at Microsoft Campus, Reading

Introduction

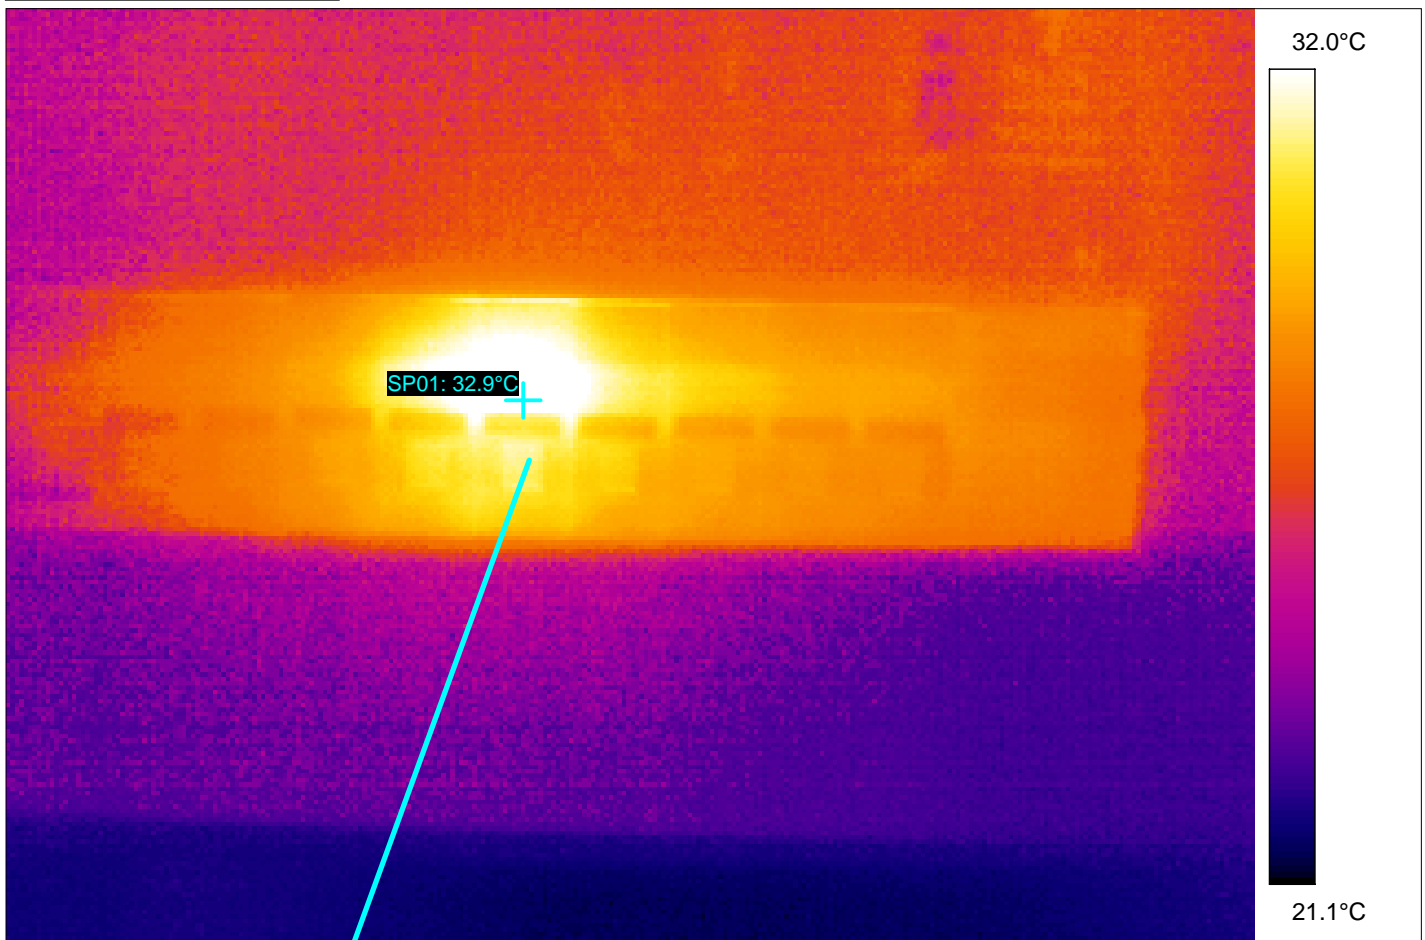
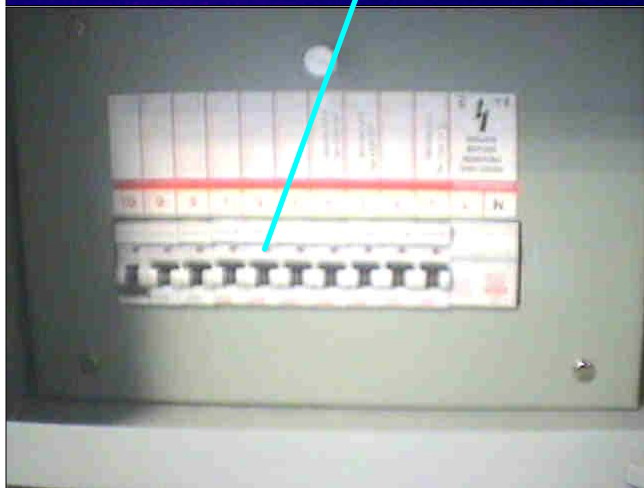
IR information	Value
Date of creation	16/08/2012
Object parameter	Value
Ambient temperature	20.0°C
Label	Value
IR : max	34.6°C
SP01	32.9°C

Section	PDU DBB
Equipment	MCB 5
Fault	High MCB operating temperature
Recommendation	Load test and check connections.
Note	As this is a Data Centre PDU it should be treated as high priority

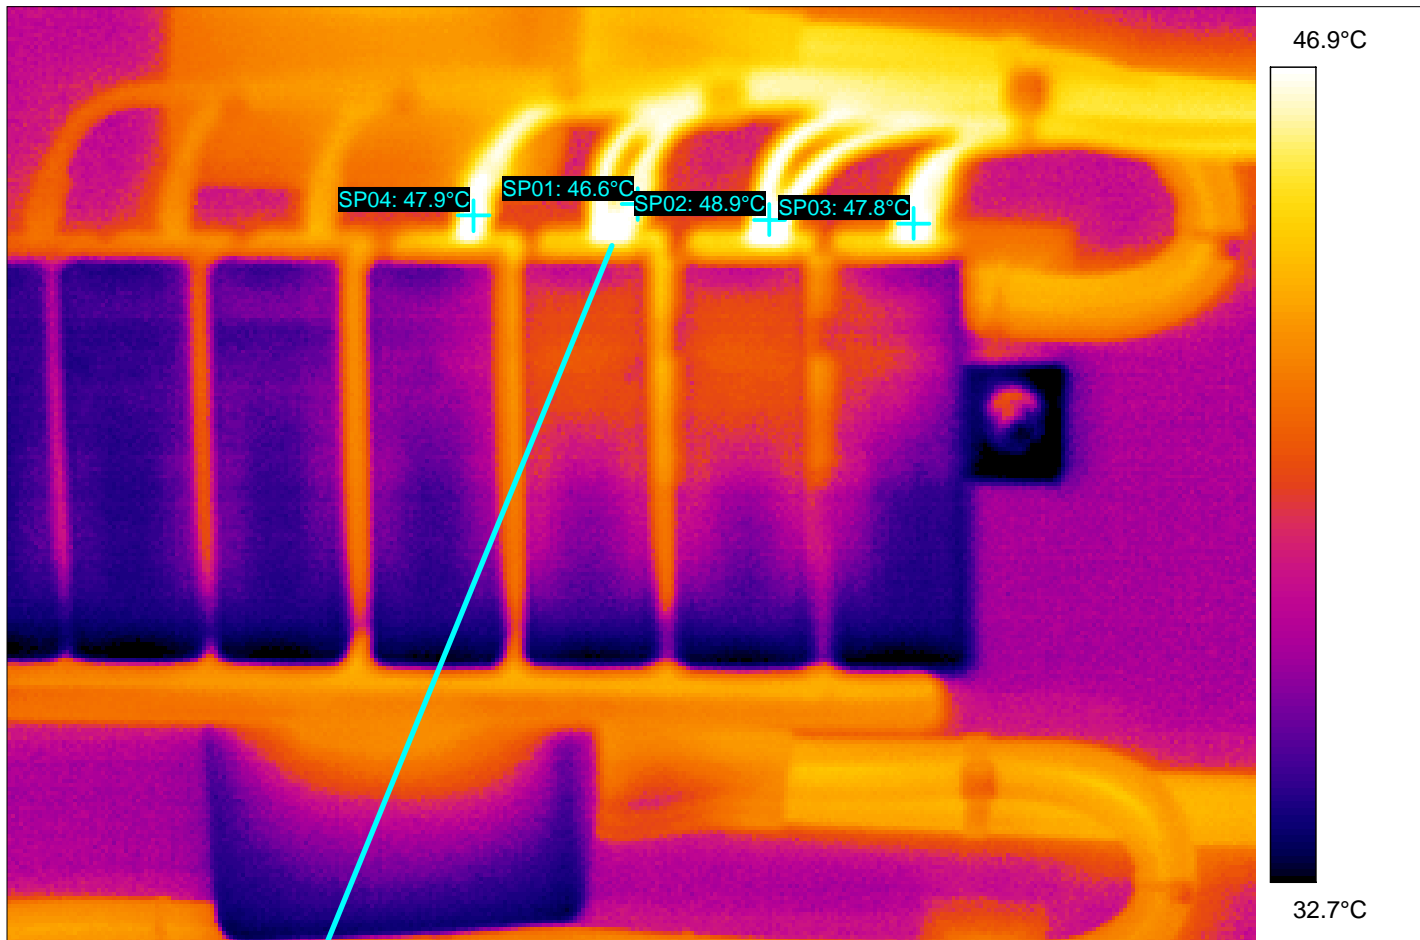
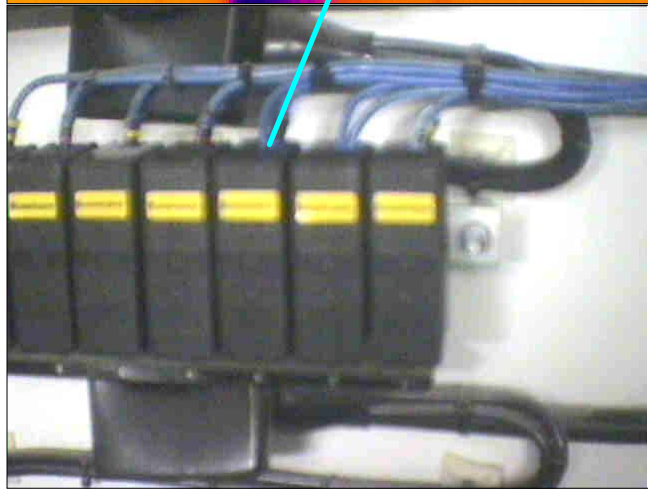
IR information	Value
Date of creation	14/08/2012
Object parameter	Value
Ambient temperature	20.0°C
Label	Value
IR : max	49.8°C
SP01	46.6°C
SP02	48.9°C
SP03	47.8°C
SP04	47.9°C

Section	Essential Vent' section MCC
Equipment	Fuses (R-L) Blue 1,2 3
Fault	High operating temperature
Recommendation	Load test & check connections and integrity of cable

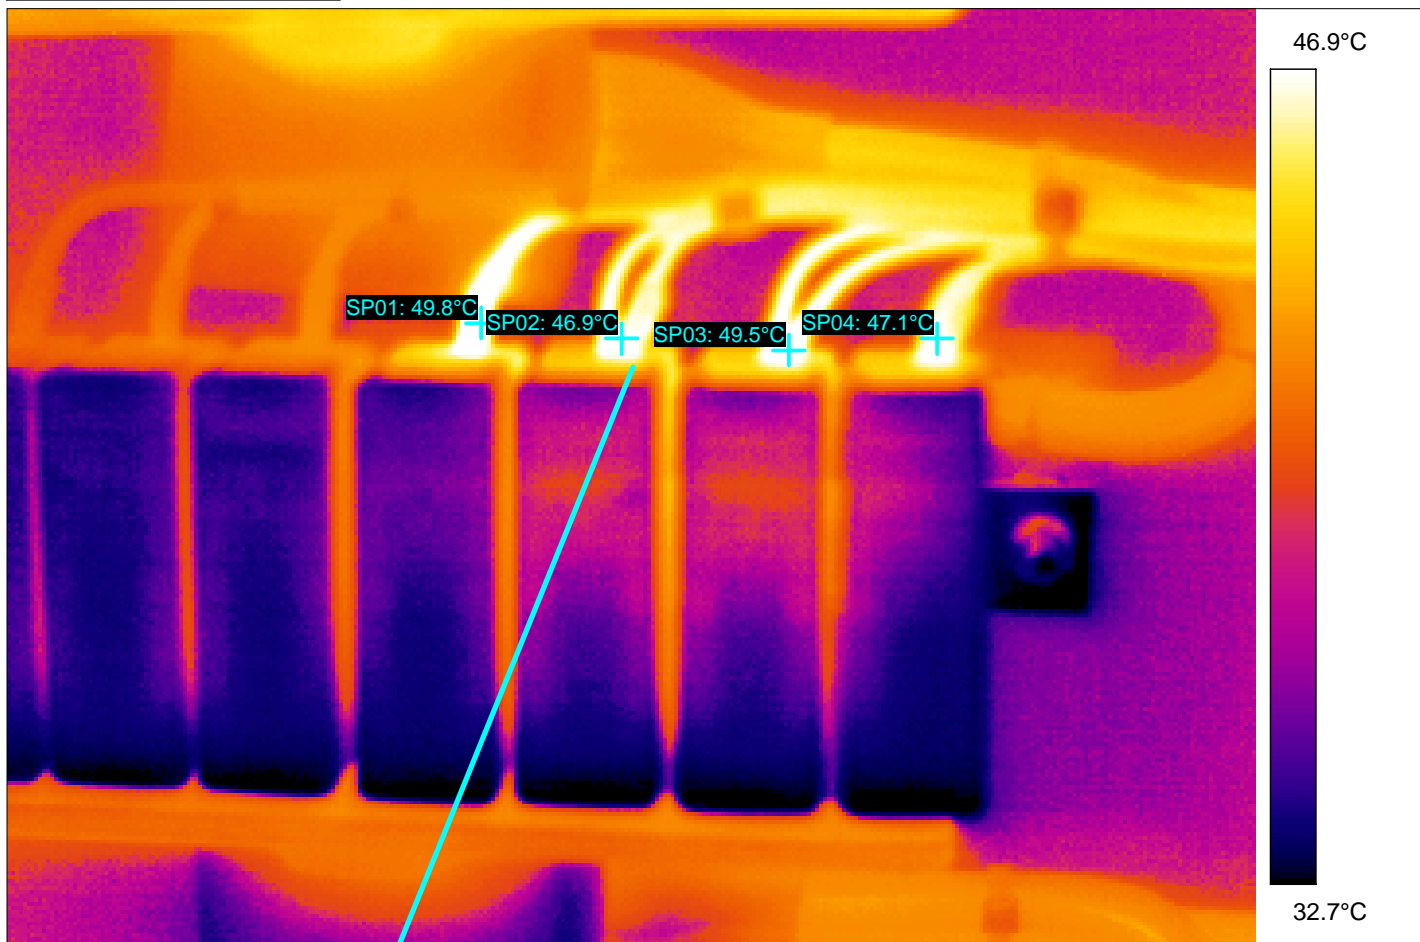
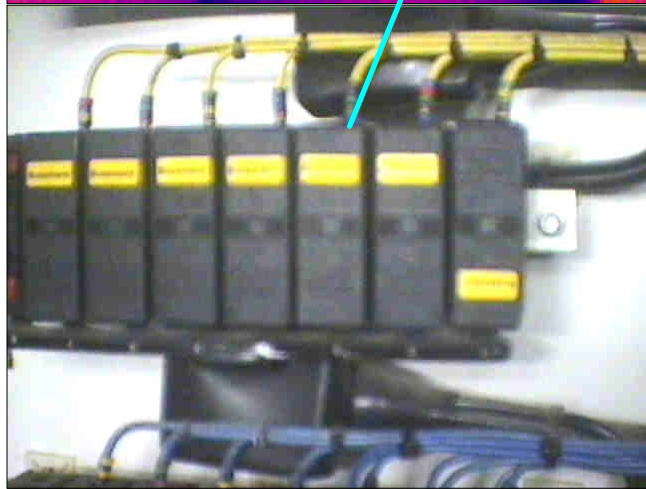
IR information	Value
Date of creation	14/08/2012
Object parameter	Value
Ambient temperature	20.0°C
Label	Value
IR : max	52.2°C
SP01	49.8°C
SP02	46.9°C
SP03	49.5°C
SP04	47.1°C

Section	Essential Vent' section MCC
Equipment	Fuses (R-L) Yellow 1,2 3
Fault	High operating temperature
Recommendation	Load test & check connections and integrity of cable

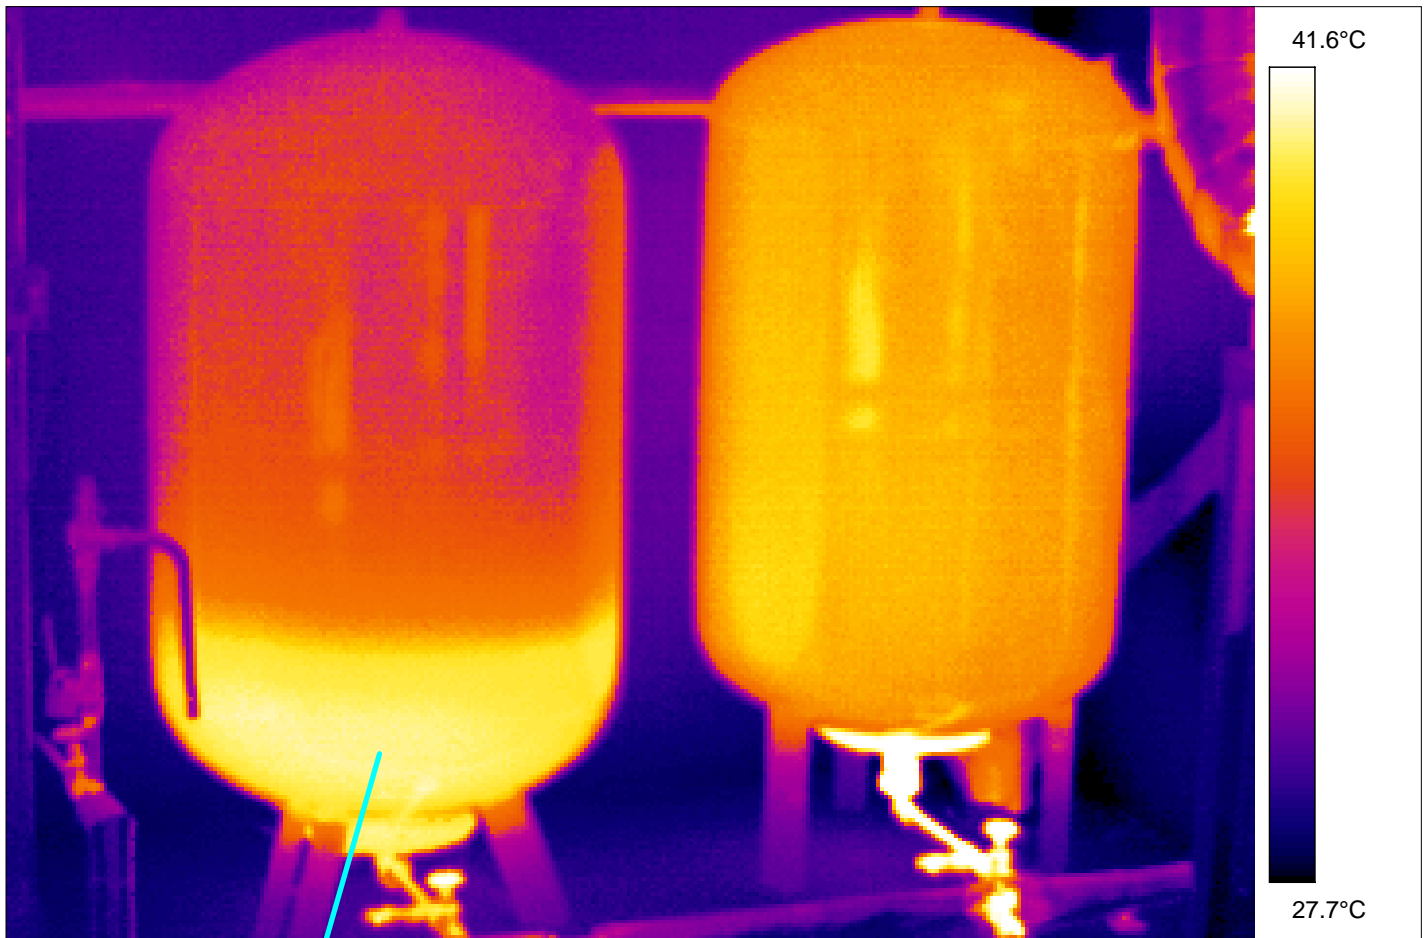
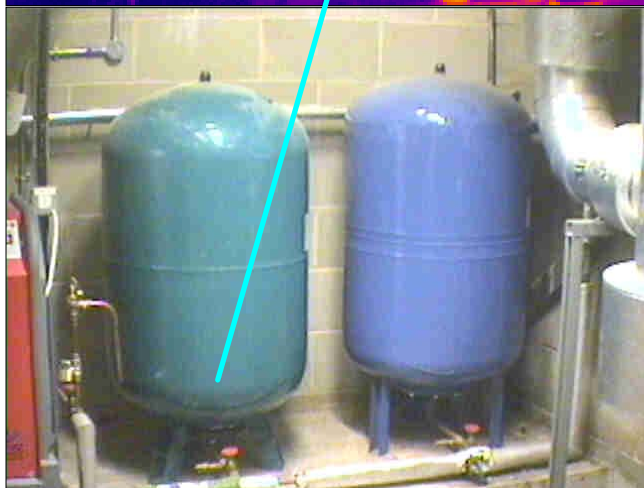
IR information	Value
Date of creation	15/08/2012
Object parameter	Value
Ambient temperature	20.0°C
Label	Value
IR : max	50.8°C

Section	Pressurisation Unit
Equipment	Left side vessel
Fault	Suspect membrane is perforated
Recommendation	Replace membrane

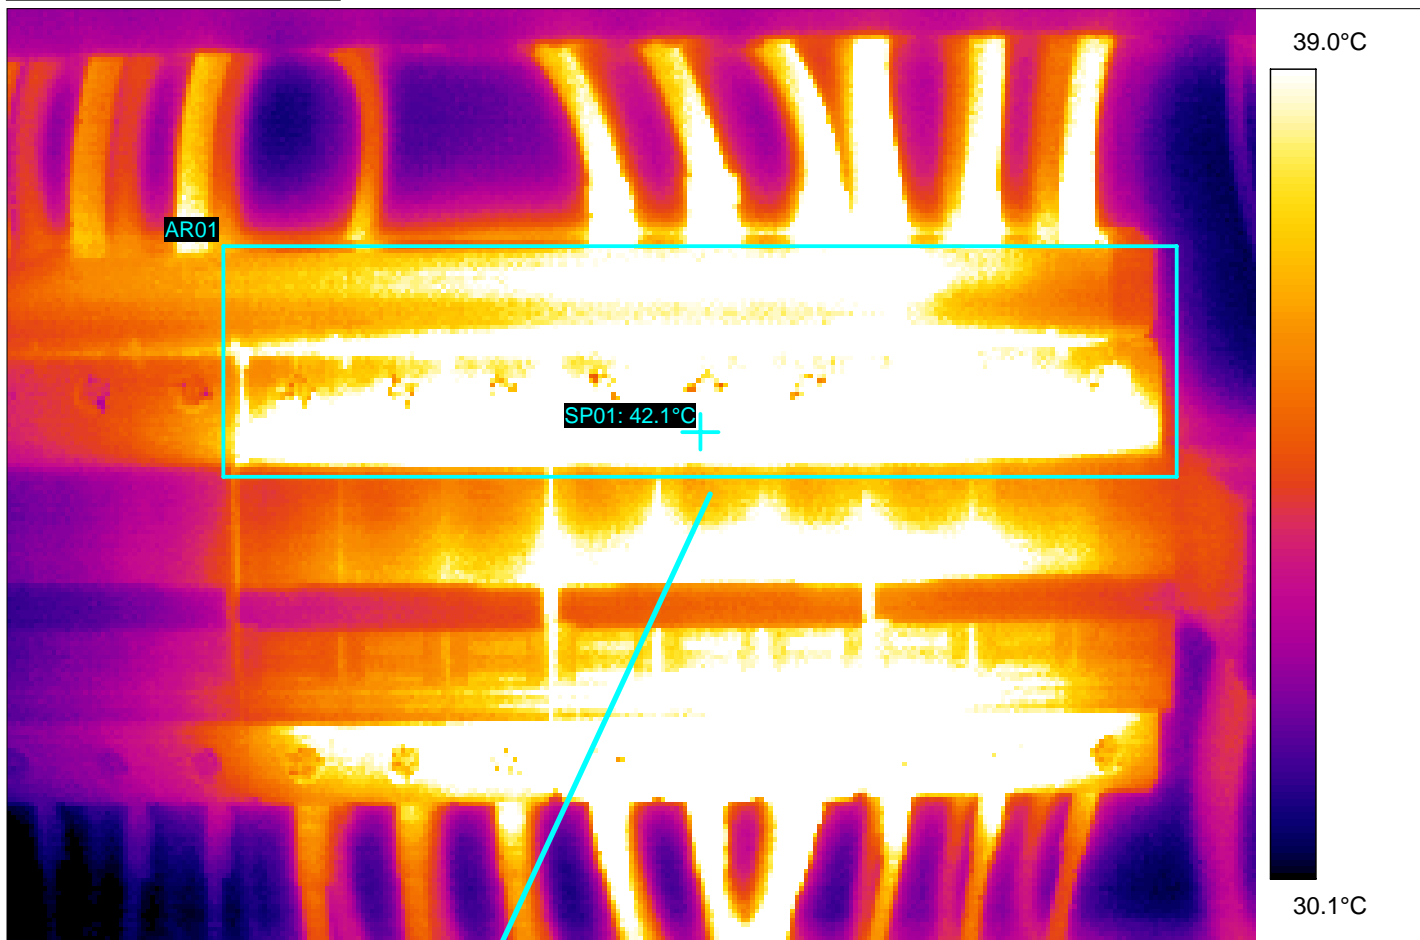
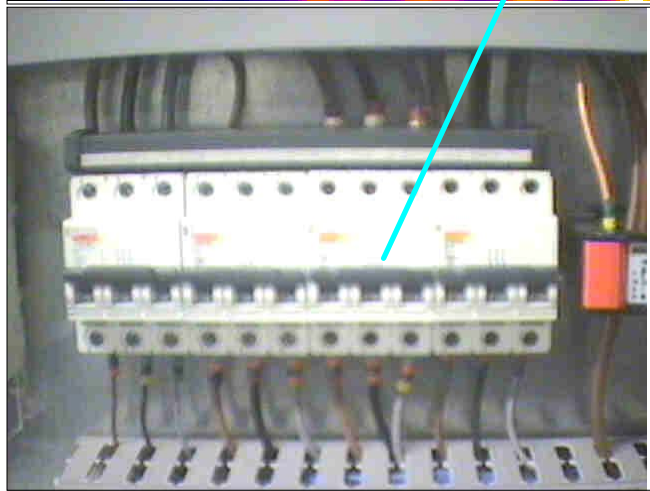
IR information	Value
Date of creation	15/08/2012
Object parameter	Value
Ambient temperature	20.0°C
Label	Value
IR : max	43.3°C
SP01	42.1°C
AR01 : max	43.3°C

Section	MSCP4 right side
Equipment	MCB4
Fault	High MCB operating temperature
Recommendation	Load test, check connections & integrity of cable
Note	I suspect the thermal pattern in adjacent eqpt is the result of conduction these MCBs and cables should also be tested.

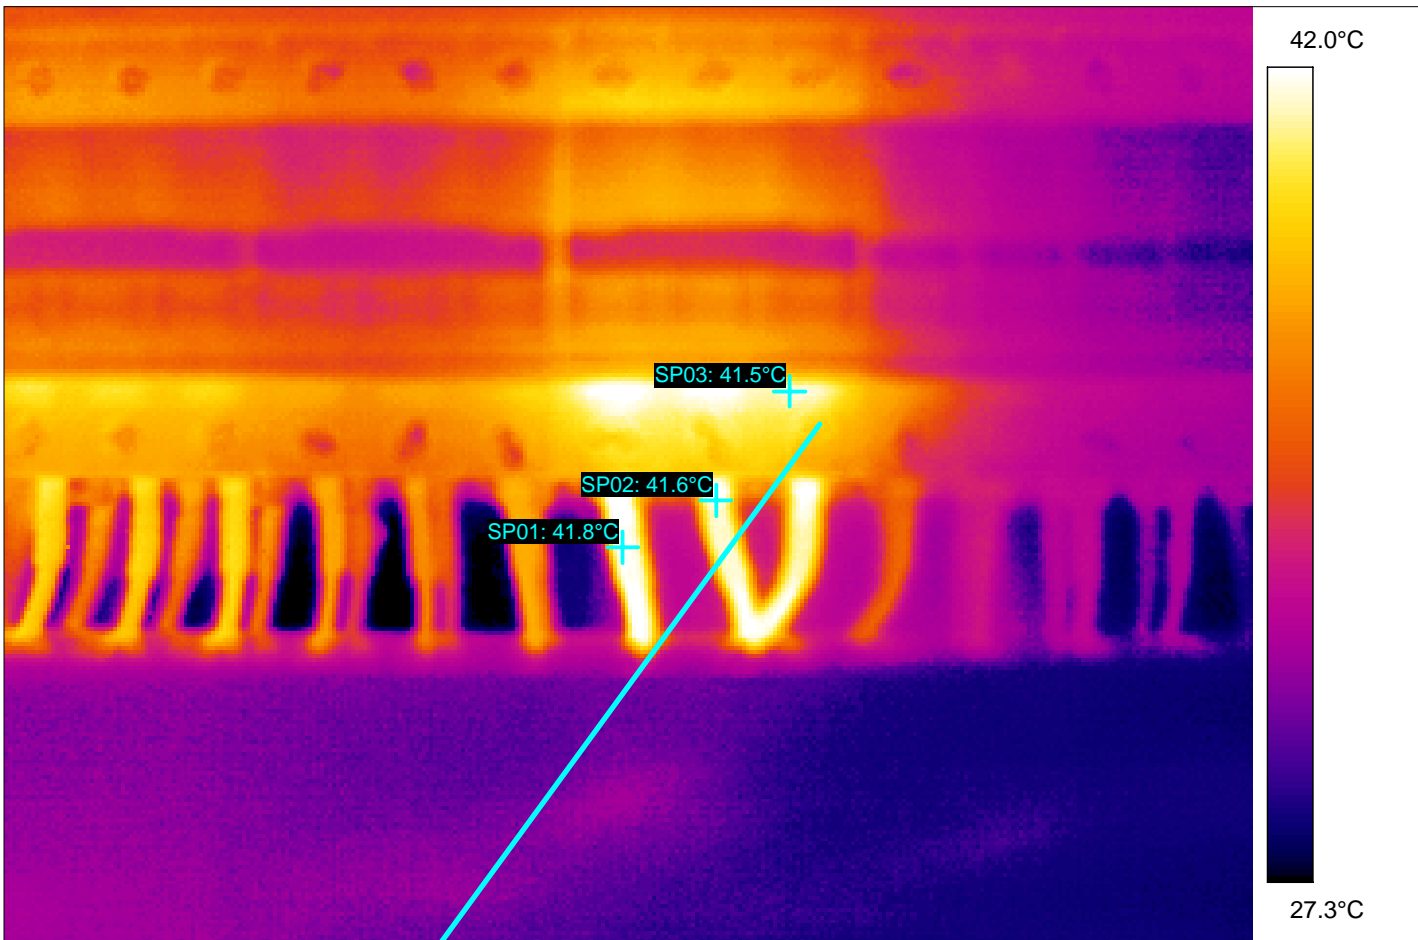
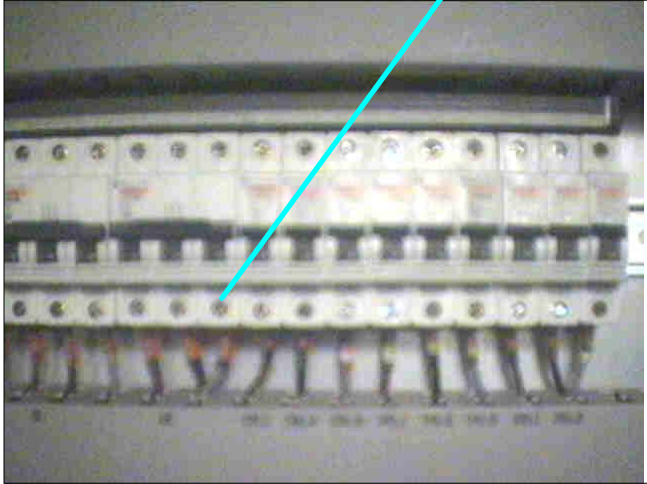
IR information	Value
Date of creation	15/08/2012
Object parameter	Value
Ambient temperature	20.0°C
Label	Value
IR : max	43.5°C
SP01	41.8°C
SP02	41.6°C
SP03	41.5°C

Section	MSCP2/3 cooling
Equipment	MCB 12
Fault	High MCB & cable operating temperature
Recommendation	Load test & check connections

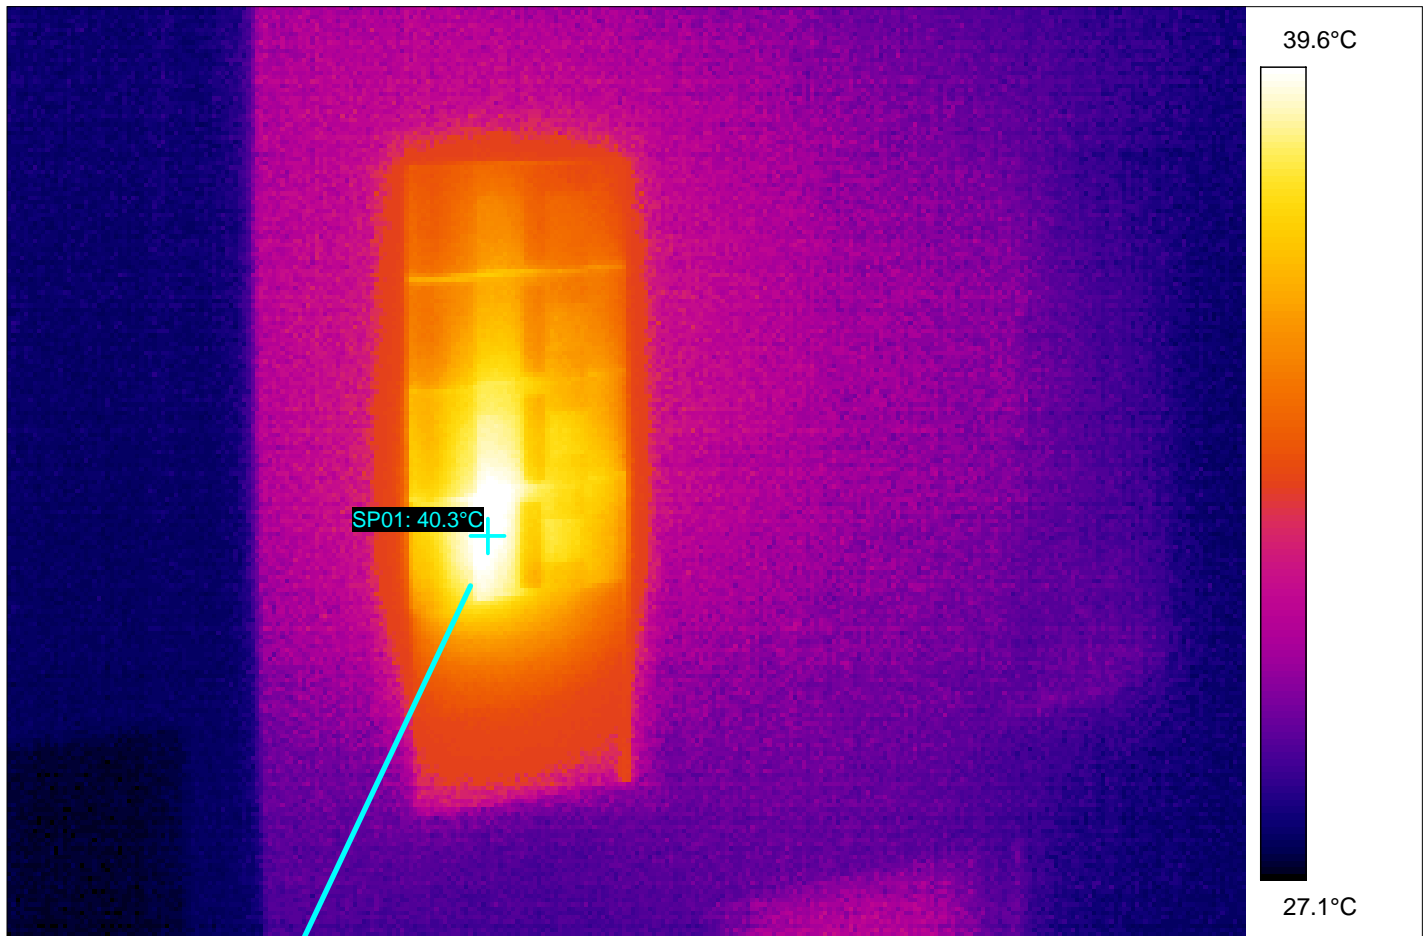
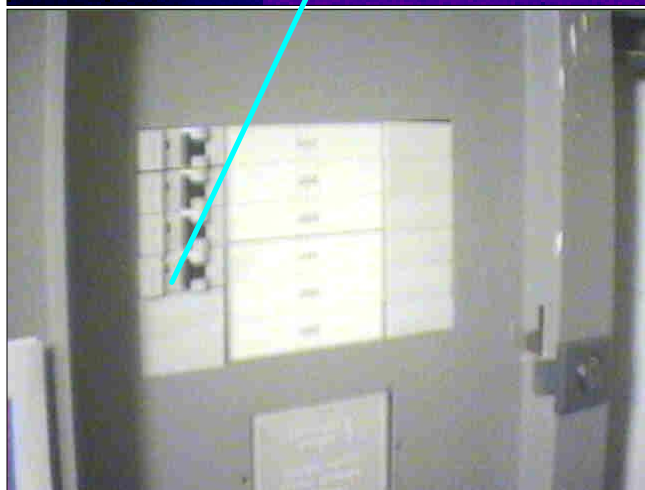
IR information	Value
Date of creation	15/08/2012
Object parameter	Value
Ambient temperature	20.0°C
Label	Value
IR : max	40.9°C
SP01	40.3°C

Section	DB 1/2A/UF
Equipment	MCB 2, L1
Fault	High MCB operating temperature
Recommendation	Load test & check connections

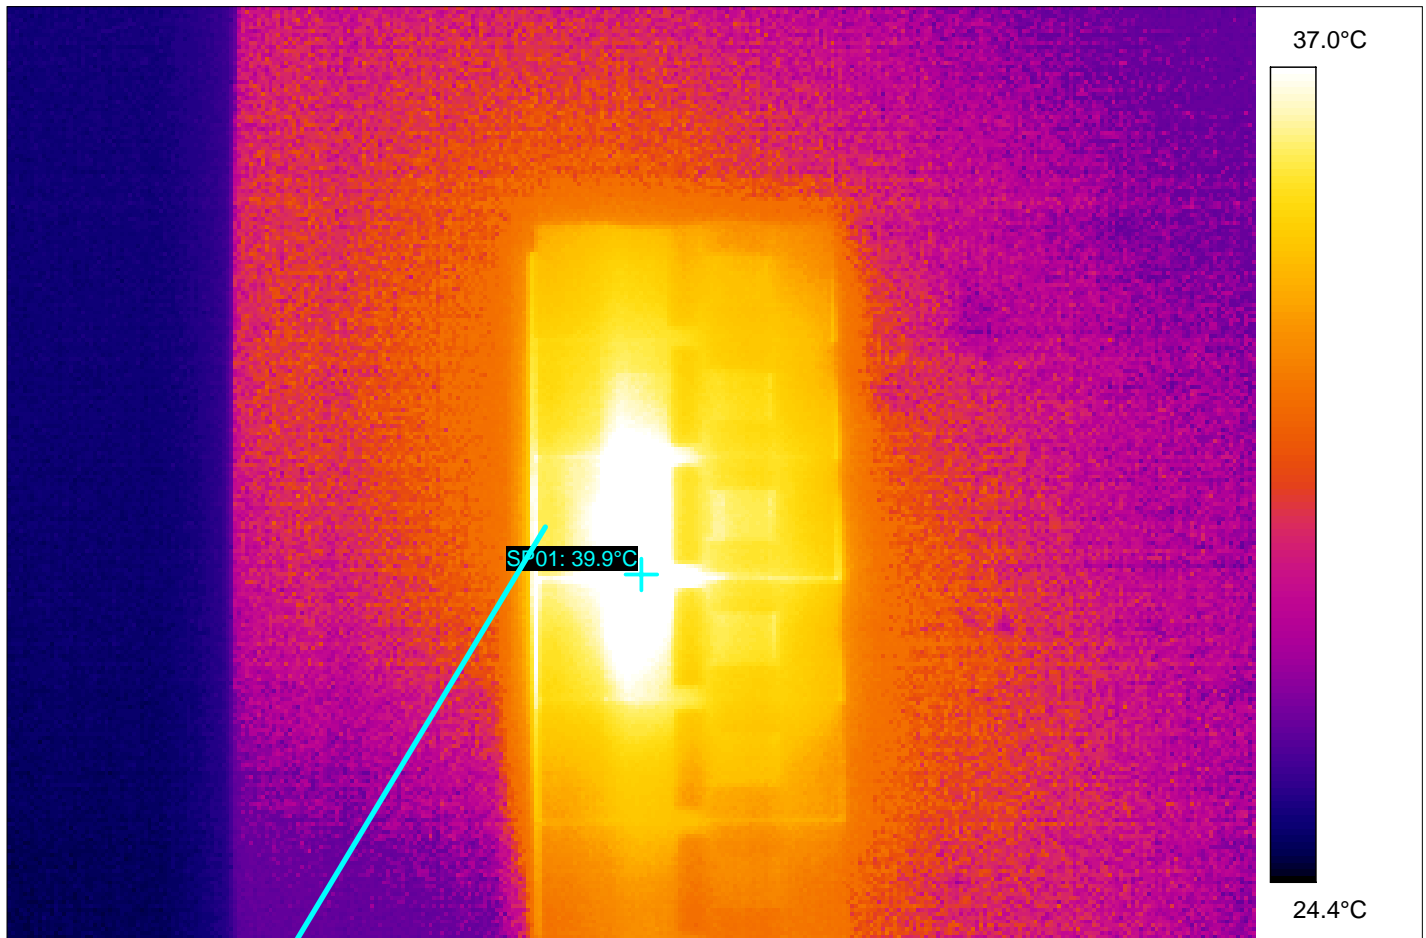
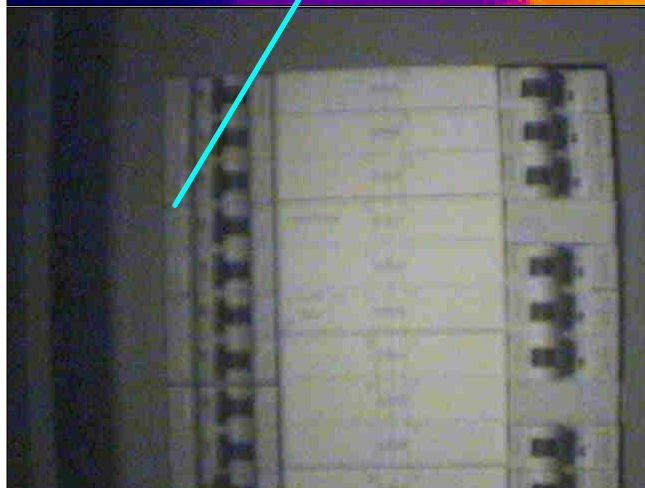
IR information	Value
Date of creation	15/08/2012
Object parameter	Value
Ambient temperature	20.0°C
Label	Value
IR : max	40.8°C
SP01	39.9°C

Section	DB G-2-2
Equipment	MCBs, 1L3, 2L1,2L2
Fault	High MCB operating temperature
Recommendation	Load test & check connections

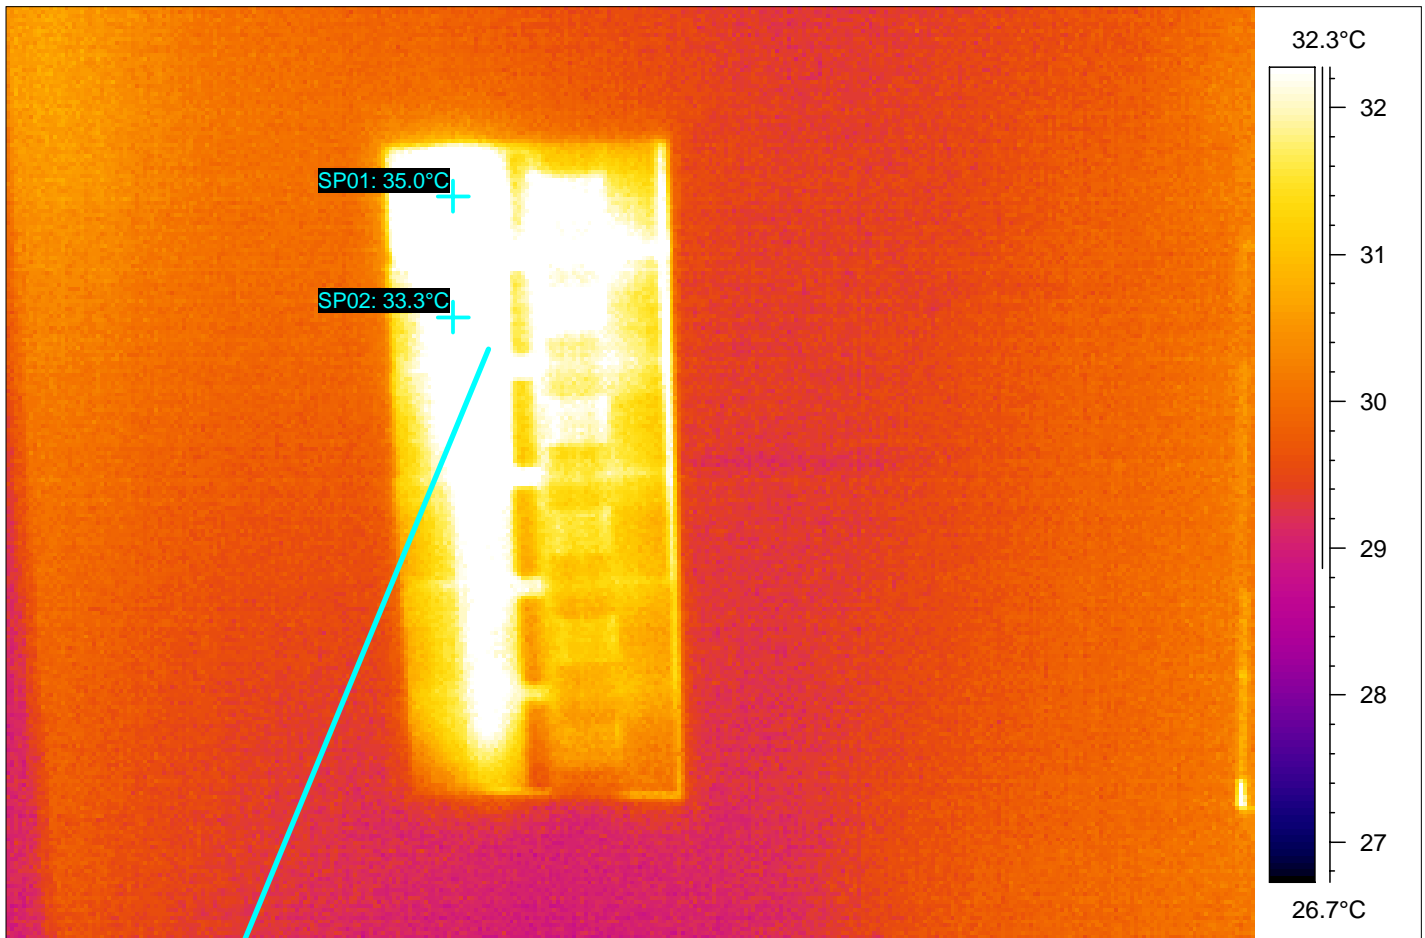
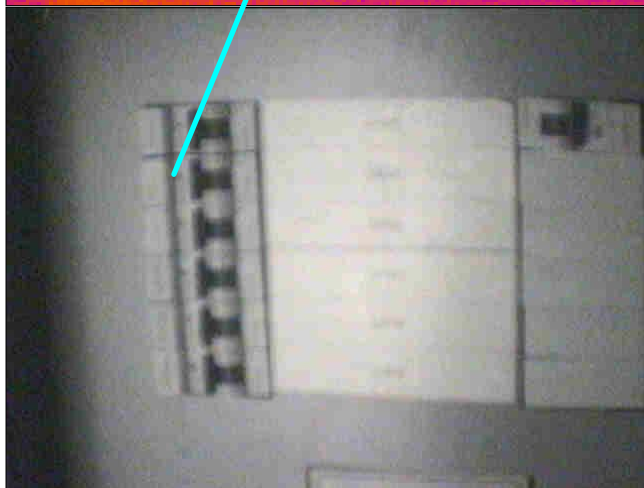
IR information	Value
Date of creation	15/08/2012
Object parameter	Value
Ambient temperature	20.0°C
Label	Value
IR : max	35.5°C
SP01	35.0°C
SP02	33.3°C

Section	DB 1/2/UF
Equipment	MCB 1, L1 & L2
Fault	High MCB operating temperatures
Recommendation	Load test & check connections

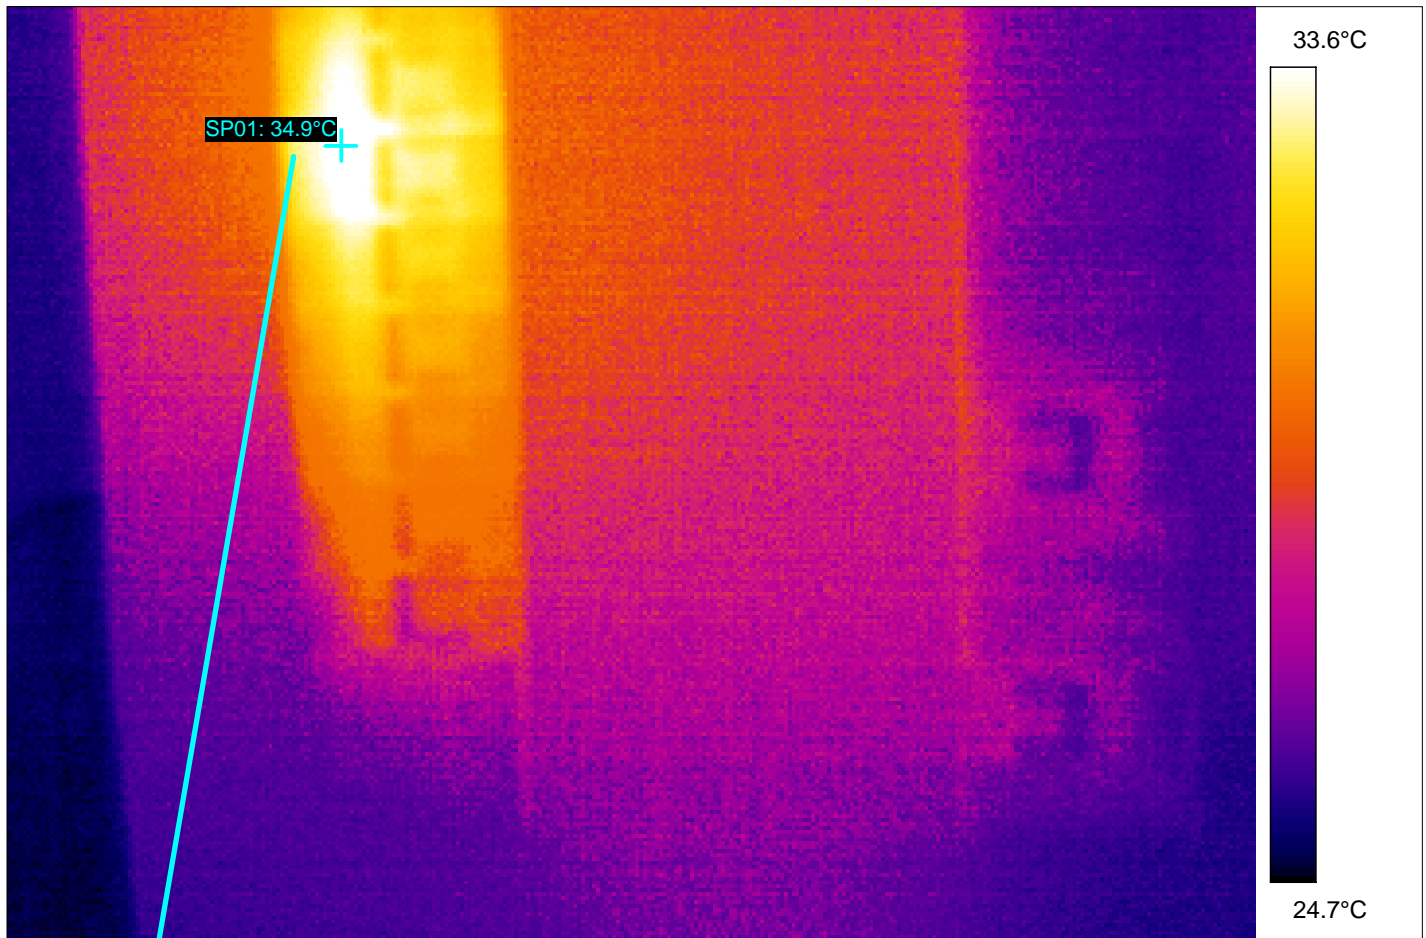
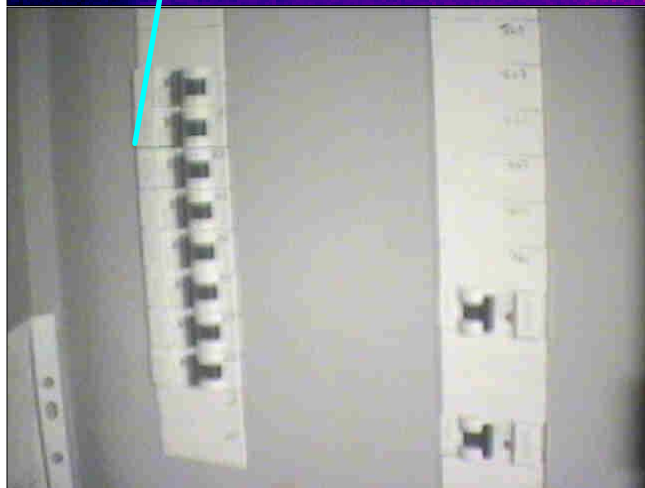
IR information	Value
Date of creation	15/08/2012
Object parameter	Value
Ambient temperature	20.0°C
Label	Value
IR : max	35.1°C
SP01	34.9°C

Section	DB 1-1-2
Equipment	MCB 2/2
Fault	High MCB operating temperature
Recommendation	Load test & check connections

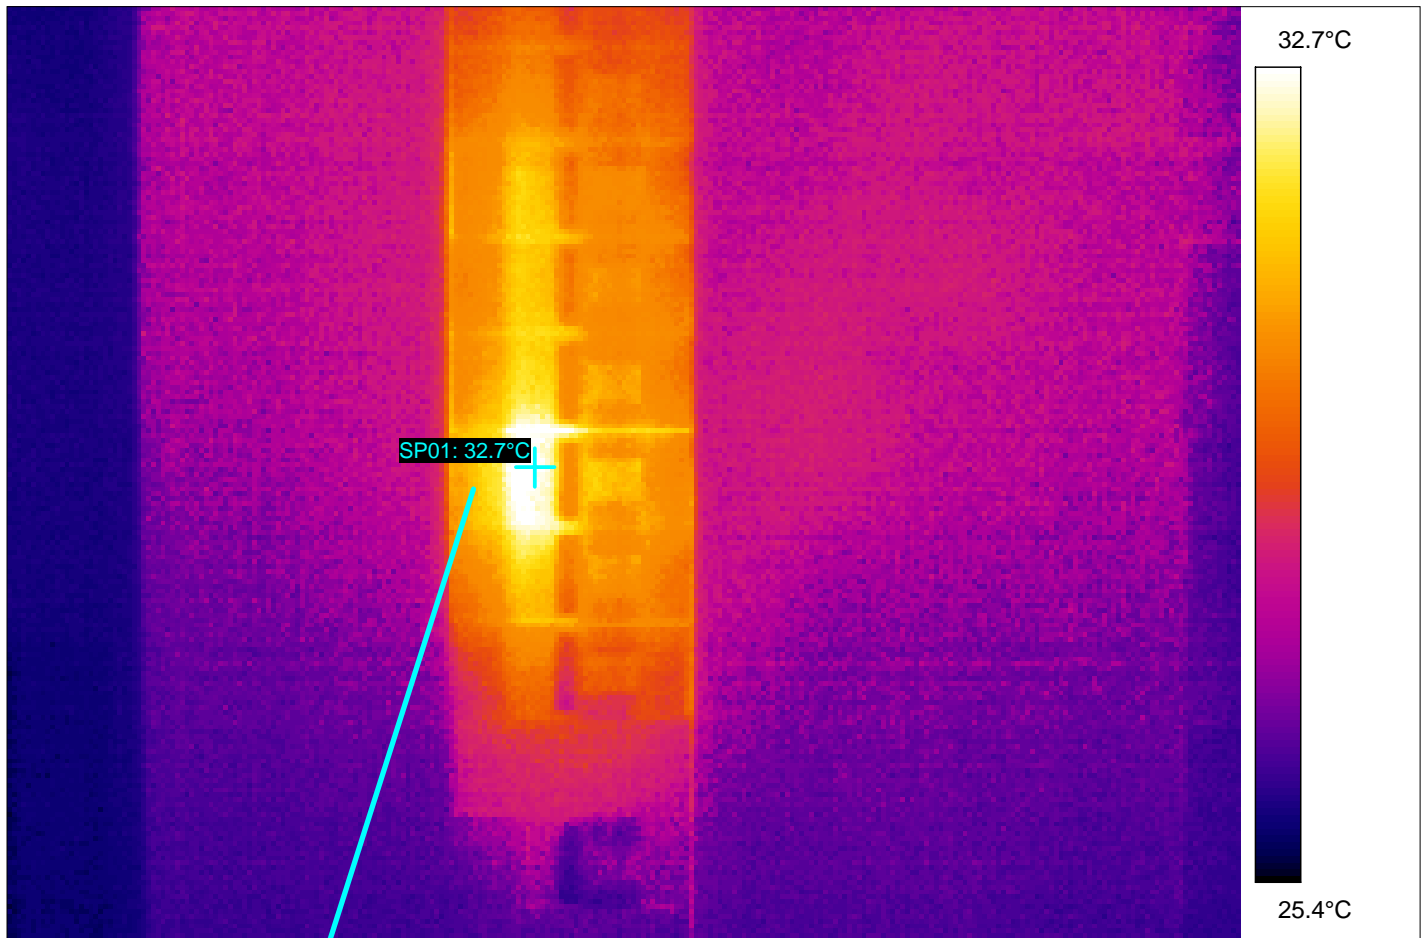
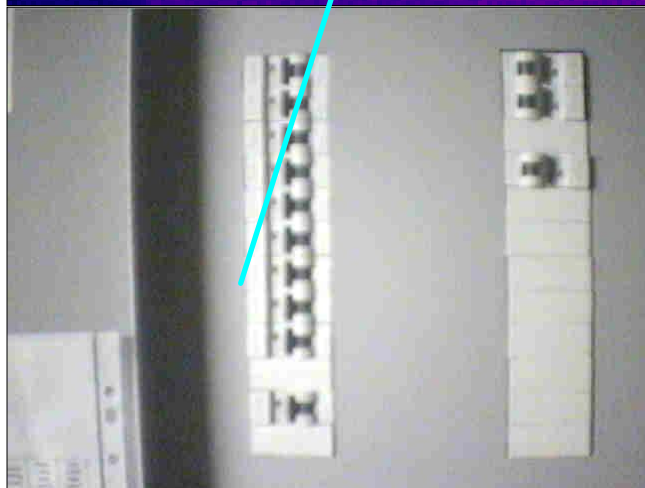
IR information	Value
Date of creation	15/08/2012
Object parameter	Value
Ambient temperature	20.0°C
Label	Value
IR : max	33.4°C
SP01	32.7°C

Section	DB 3-2-2
Equipment	MCB 3L1
Fault	High MCB operating temperature
Recommendation	Load test and check connections.
